STRESS CORROSION CRACKING OF ROCK BOLTS

Erwin Gamboa

A THESIS SUBMITTED TO THE UNIVERSITY OF QUEENSLAND
FOR THE DEGREE OF DOCTOR OF PHILOSOPHY

NOVEMBER 2004

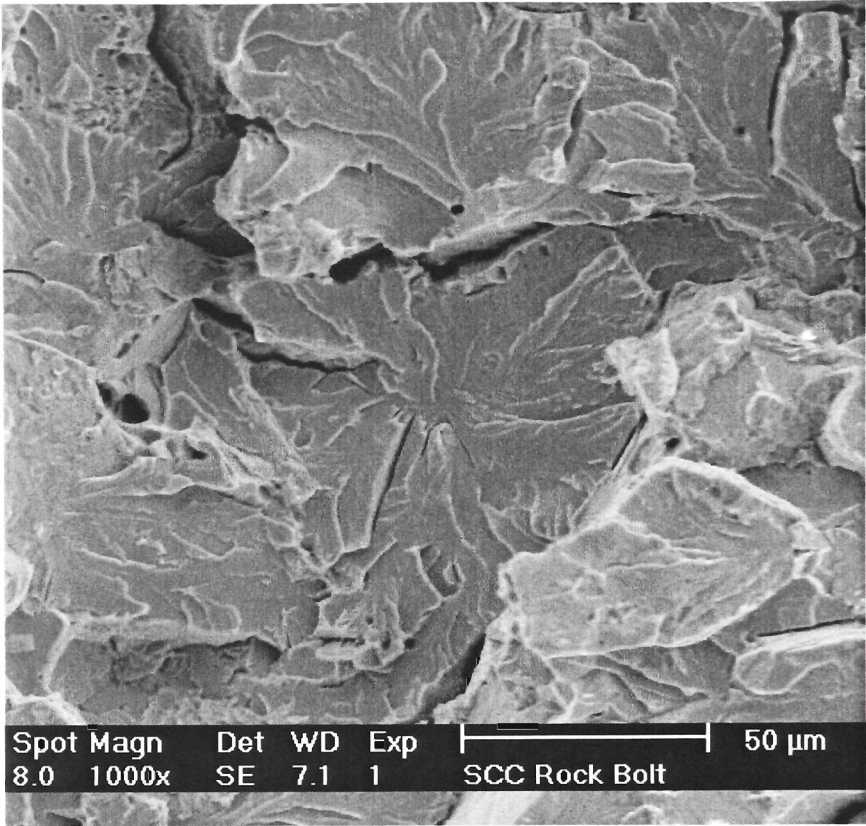
a small SCC region followed by a large fast fracture (FF) region. Figure 5.2 provides a typical overview for a service fracture. The SCC region was easily identified by its darker colour due to the presence of corrosion products on the metal surface in the SCC region. This was due to the fact that the stress corrosion cracks grew slowly, allowing a period of time for corrosion to occur. In contrast, the overload region occurred essentially instantaneously, so that the surface was bright and shiny as an un-oxidized steel surface. The tear lines radiated away from the fracture origin. These tear lines facilitated the identification of the SCC feature that initiated the final fast fracture event. It was particularly noteworthy that the service stress corrosion cracks often initiated in association with the ribs on the surface of the rock bolt as illustrated in Figure 6.1.

FIGURE 6.1: Overview of the dark thumbnail area on the rock bolt fracture surface.

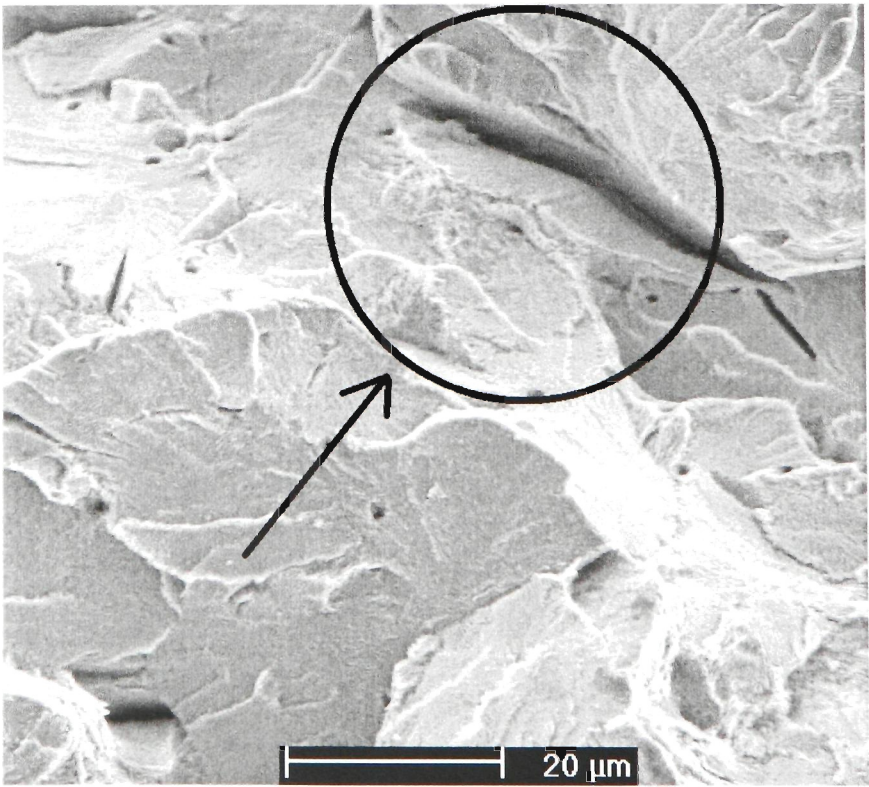
FIGURE 6.2: Detail of FFS at x1000 magnification.

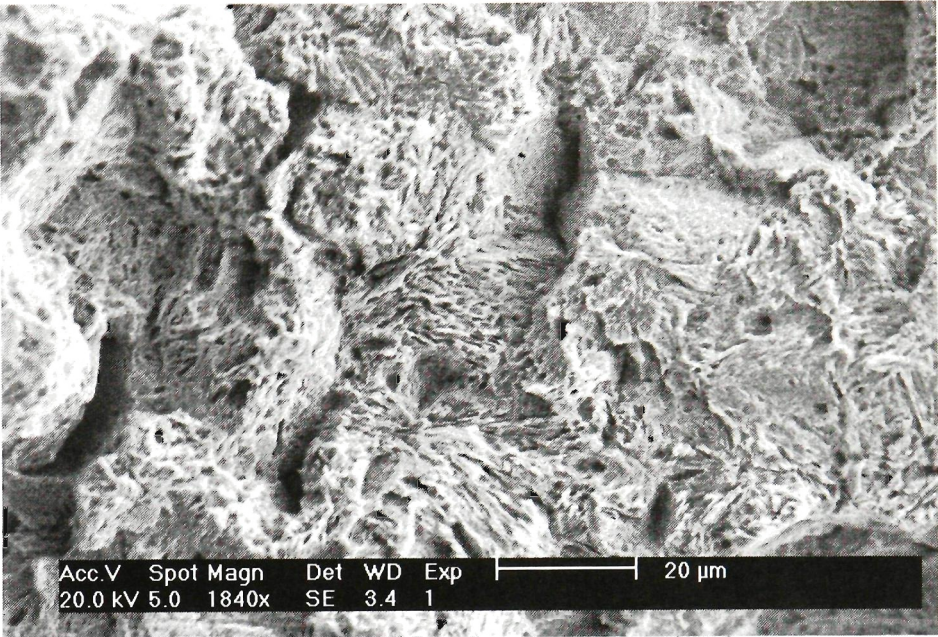
Chasms sometimes occurred between the maple leaves. This separation was thought to be caused by the material ahead of the fast crack tip yielding plastically, pulling open the grain boundary by a small amount before the brittle crack reached around this plastic region and severed the plastic yielding tendril. This was supported by the dimpled rupture region in Figure 6.3, where just below the chasm there was a dimpled rupture region bounded by the flat featureless surface of the fast fracture region.

FIGURE 6.3: Detail of a chasm in FFS.

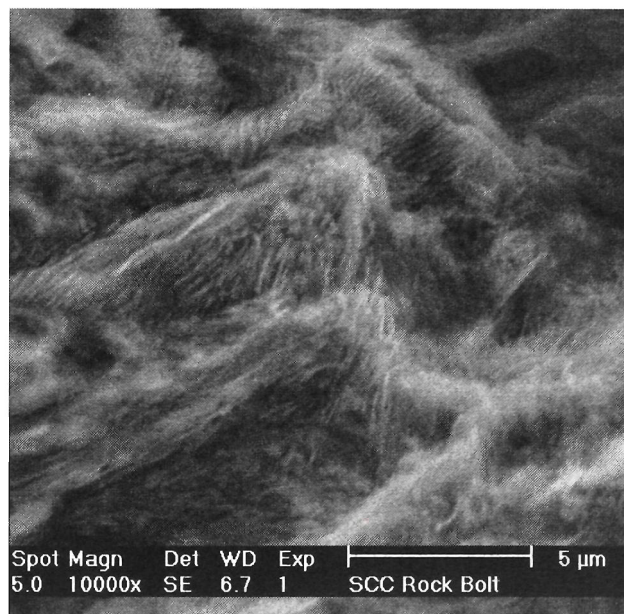
Figure 6.6 was an overview of the SCC region. This shows tear lines on the FFS pointing towards the thumbnail shaped area on the bottom of the Figure. The brittle fracture region typically covered 98% of the total rock bolt surface area.

FIGURE 6.6: Overview of a typical SCC region in a rock bolt.

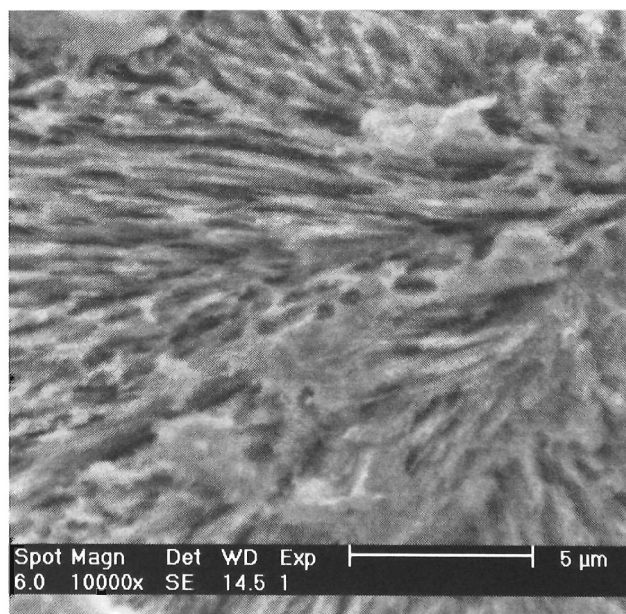
The features in the SCC region of rock bolts were several and varied. The most striking feature was the network of corrugated surfaces, joined by rough slopes. These corrugated surfaces displayed a network of branched channels, initially believed to be formed by the preferential corrosion of one of the components of a pearlite colony. The spacing between these channels was 200 nm. Further study showed that these spacings were independent of pearlite lamellar orientation and were not caused by preferential corrosion. This spacing was the same as that found in the maple leaves, being the spacing between the ferrite and pearlite in the pearlite colony. In these cases, the crack tip had been travelling perpendicularly to the main pearlite colony axis. Figure 6.8 shows one such surface.

FIGURE 6.8: Flat ridged area.

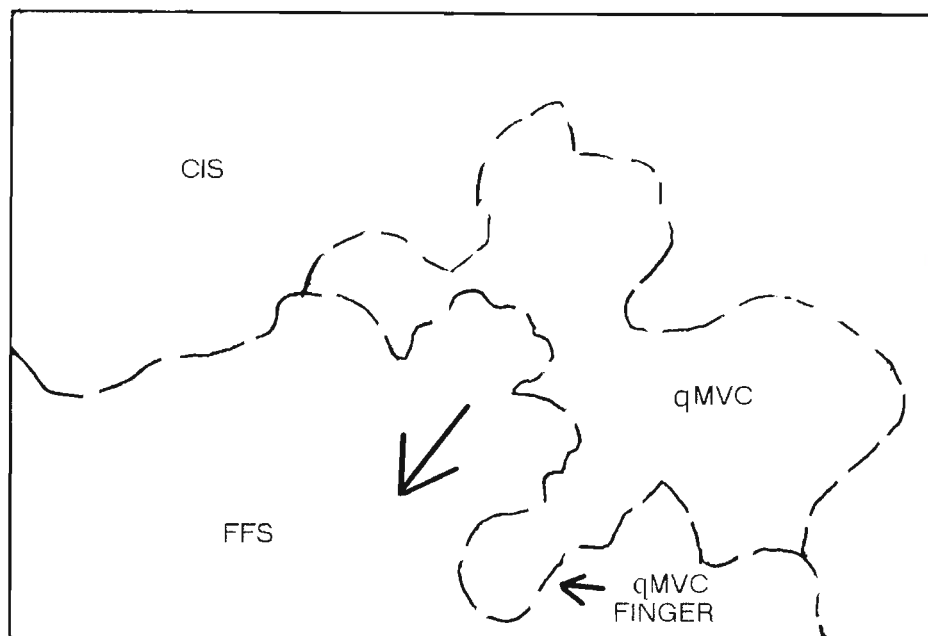
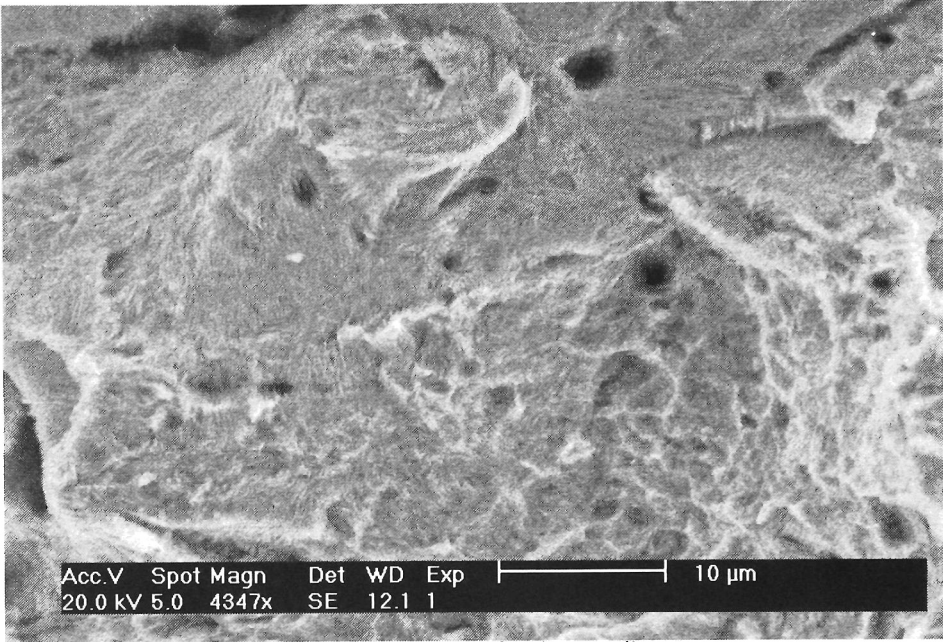
Figure 6.16 shows a qMVC region that has grown as a “finger” into the FFS region, whilst the rest of the qMVC-FFS interface was a relatively straight line. These fingers could extend into the FFS region by a much greater amount than the 50 microns mentioned previously. Fingers have been detected of up to 350 microns in length, but tended to be a maximum of 100 microns across. These fingers were attributed to hydrogen finding a path that allowed easier diffusion into the material.

(b) Schematic view showing a qMVC "finger" extending into the FFS. Large arrow shows crack growth direction.

FIGURE 6.16: Typical SCC-MVC-FFS interface

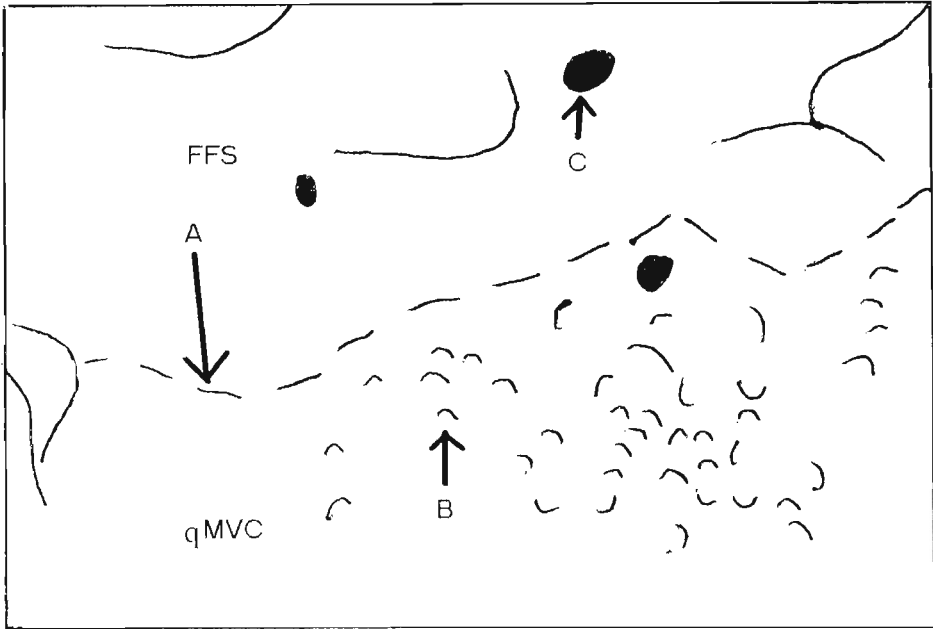
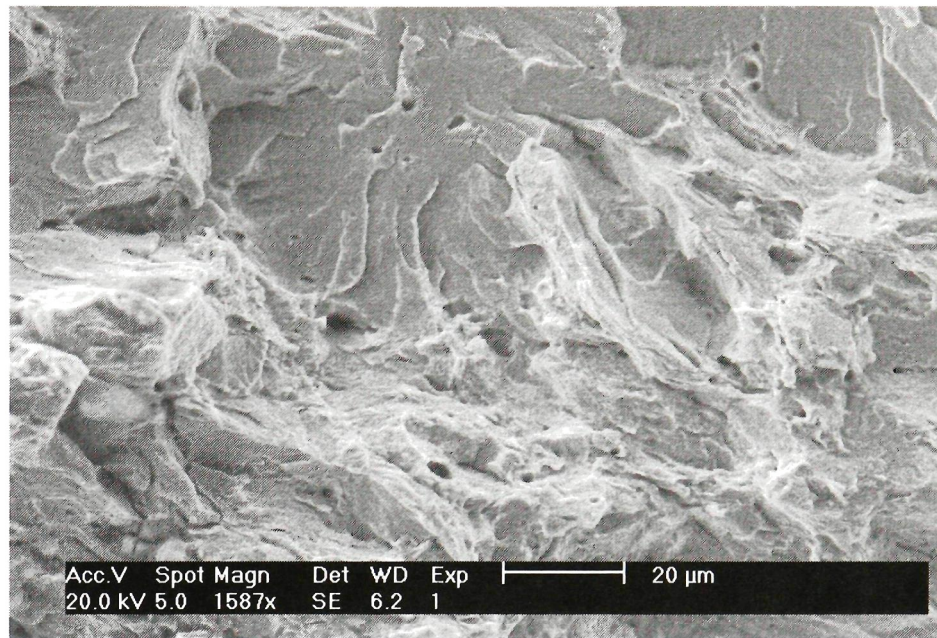
The interface between SCC and FFS was created by the edges of the maple leaves appearing to be the transition line. The straightness of such a line suggested that the crack propagated as a front. Once the crack reached a critical size, the fast brittle failure occurred along the front at the same time. In many of those places, the crack propagated outward producing the maple leaf pattern. This resulted in the edges of the maple leaves creating a distinctive line along the crack front. The line could easily be identified as the FFS side was quite smooth and flat, while the SCC side could be rough and dimply. In some cases, the separation between CIS and qMVC was not so clear, as the transition region resembled a flat irregular dimpled surface (as in Figure 6.17). This irregular dimpled surface was where hydrogen has had some time to

(b) A: Dashed line showing qMVC-FFS interface, B: qMVC dimples, C: Holes

FIGURE 6.17: Flat region within the SCC-FFS interface (x4347)

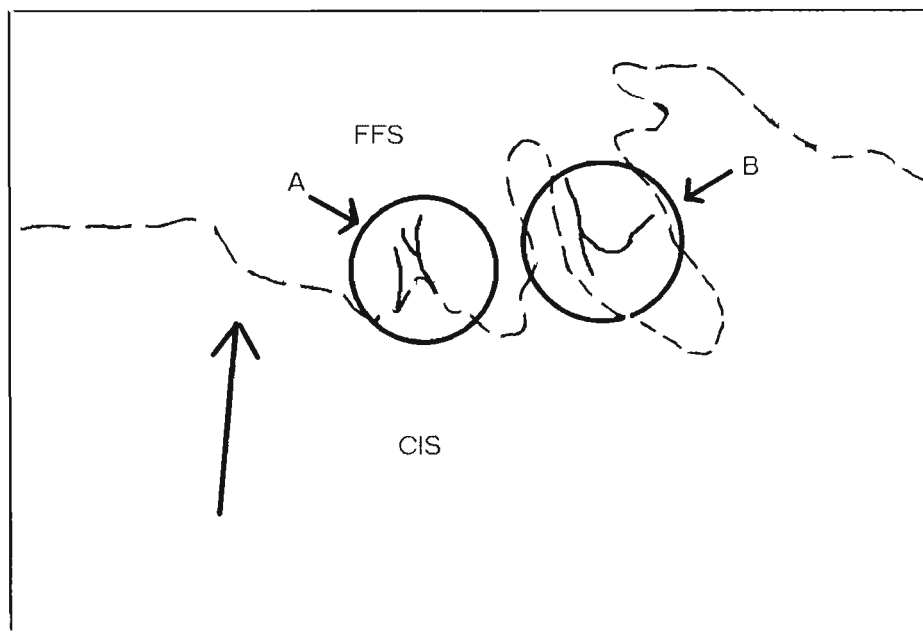
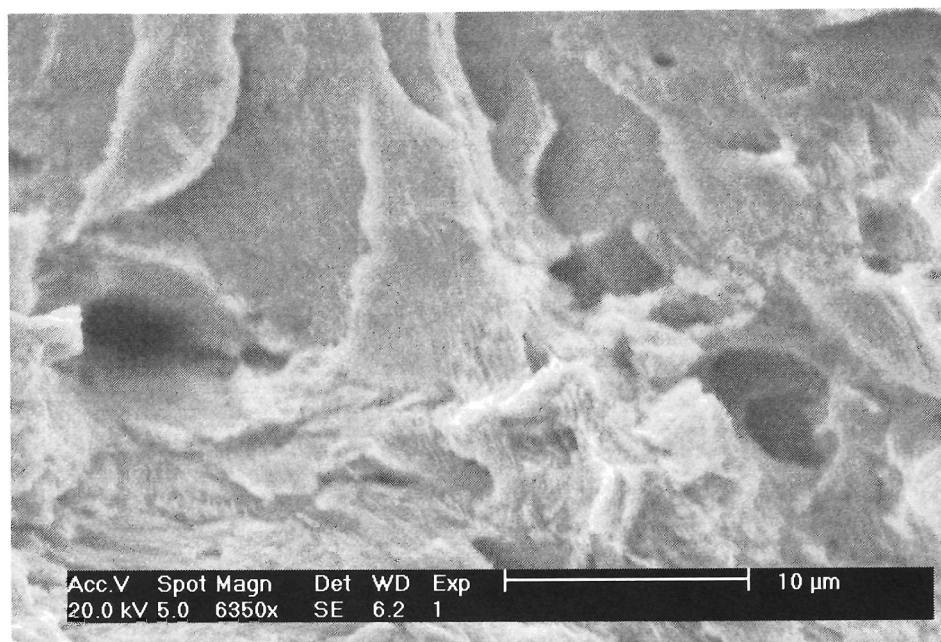
(b) Schematic view showing SCC(CIS) and FFS regions. Large arrow shows crack growth direction. A: Figure 6.19, B: Figure 6.20

FIGURE 6.18: Typical SCC(CIS)-FFS interface (x1587)

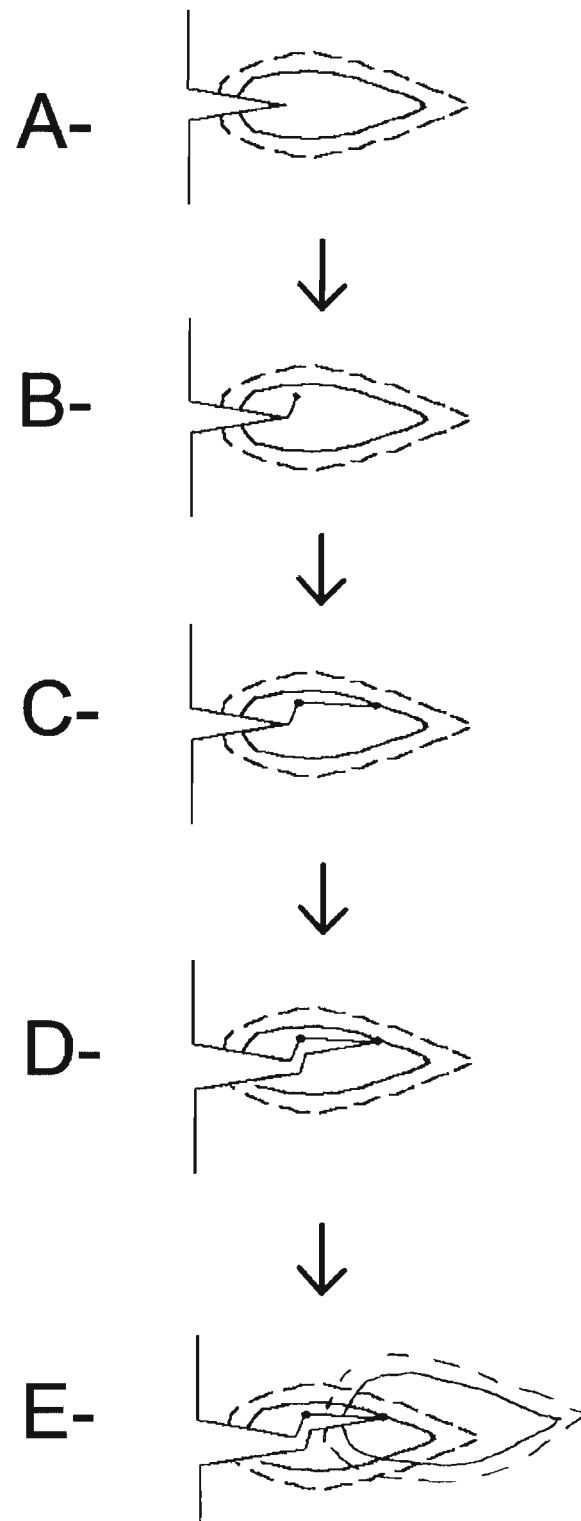
The resulting region of critical hydrogen concentration resembled the shape of a flame, as illustrated in Figure 6.23. This shape was the result of two effects. The first effect was the diffusion of hydrogen into the material, driven by the concentration gradient and the triaxial stress at the crack tip. The region of hydrogen concentration due to the concentration gradient was a sphere around the crack tip, as shown in A. The second effect was due to the tensile stress present. The tensile stress (lower than the yield stress) caused the atomic bonds to stretch. Due to the stress concentration caused by the crack, the local stress at the crack tip was higher than inside the material, hence the atomic bonds at the crack tip were stretched elastically more than those further into the material. This is illustrated in B. As the bonds were stretched, the hydrogen atoms found an easier passage into the metal matrix than through the unstretched material. The resulting hydrogen concentration envelope is illustrated in C. By adding these two effects, the envelope of total hydrogen concentration is represented by D. Outside that envelope there still was hydrogen diffused

FIGURE 6.23: Critical hydrogen envelope

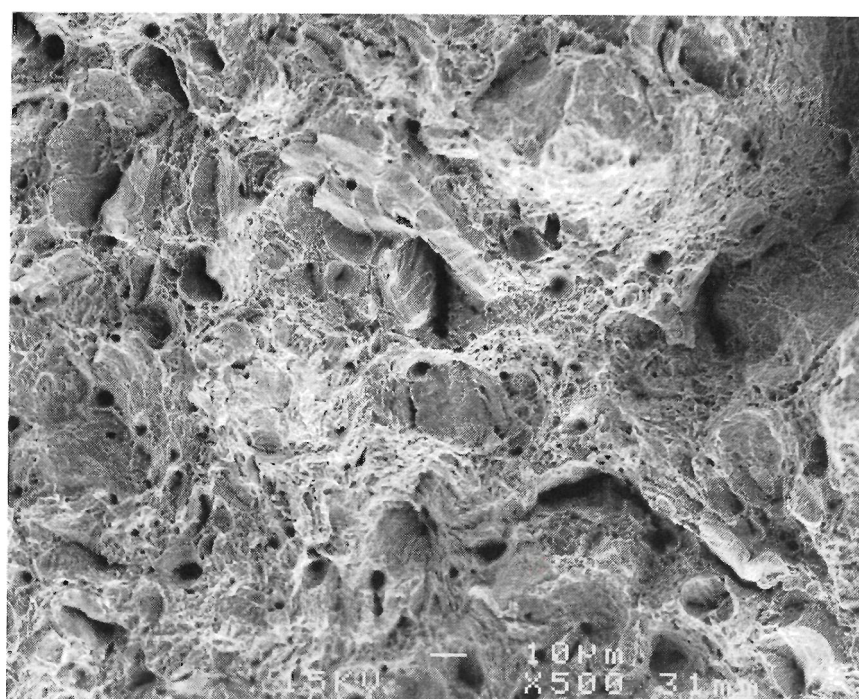
Figures 6.26, 6.27 and 6.28 characterise a ductile fracture for LIST sample EG01, which was subject to a tensile test in air in the Instron tensile testing apparatus.

These pictures show the typical cup-and-cone fracture surface. The dimple rupture was clear in all three pictures, shown as the porous uneven surface with large variations in depth. The dark region to the right of the centerline of Figure 6.26 is caused by a piece of lint that landed on the sample prior to insertion into the microscope. The uncondusive lint charged up and deflected the electron beam from the region.

FIGURE 6.26: Overview of EG01 sample

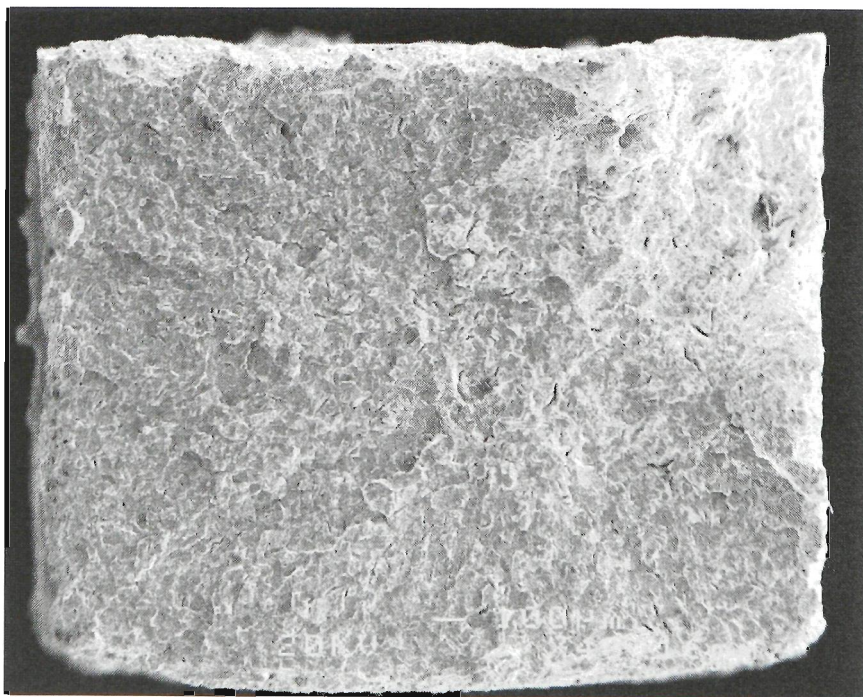
No SCC and ductile overload fracture occurred for the LIST test in the “sulphate pH 2.1” solution for the relatively fast stress rate of 0.19 MPa s^{-1} . In contrast, SCC occurred at the slower applied stress rates 0.019 and $0.0019 \text{ MPa s}^{-1}$ in the “sulphate pH 2.1” solution. Figures 6.29 and 6.30 present fracture surfaces typical of those observed in the sulphate pH 2.1 solution. These fracture surfaces were similar to the fracture surfaces of the rock bolts failed in service by SCC.

FIGURE 6.29: Overview of SCC in a LIST sample

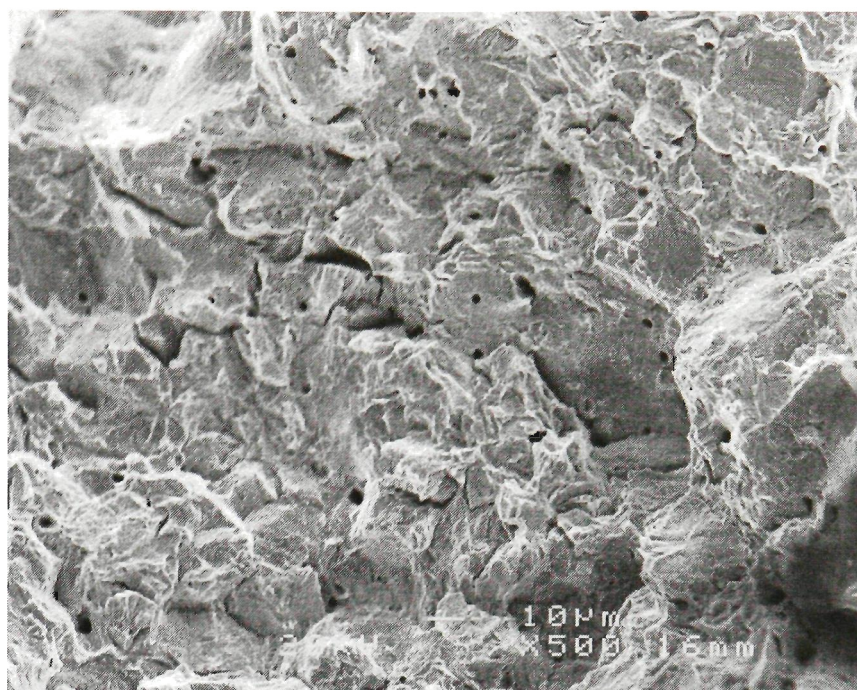
FIGURE 6.30: Detail of LIST SCC

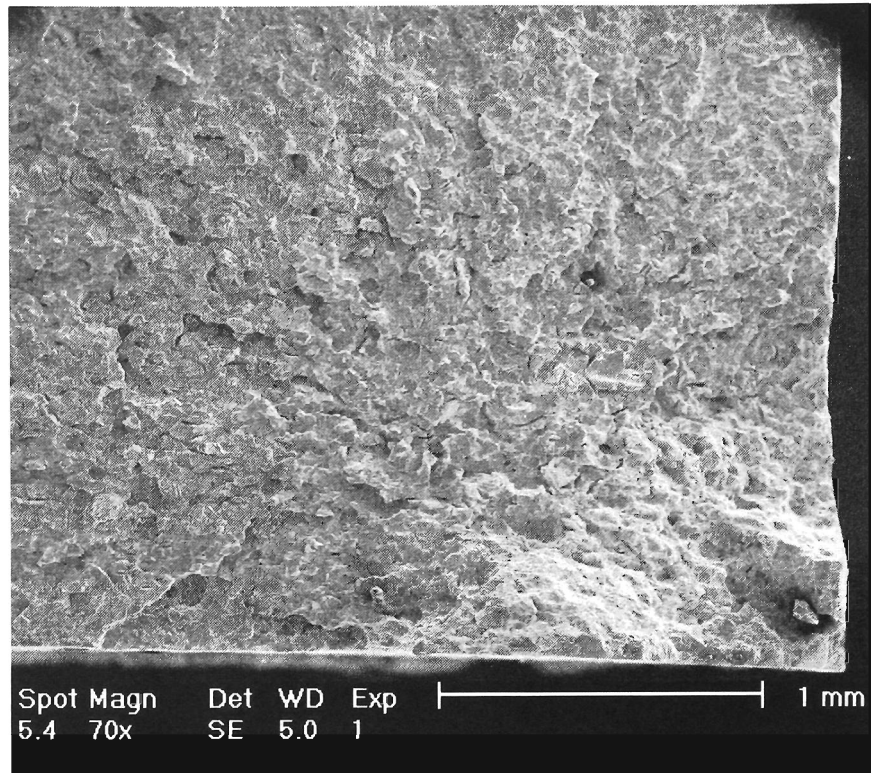
FIGURE 6.32: Detail from Figure 6.31 showing SCC area.

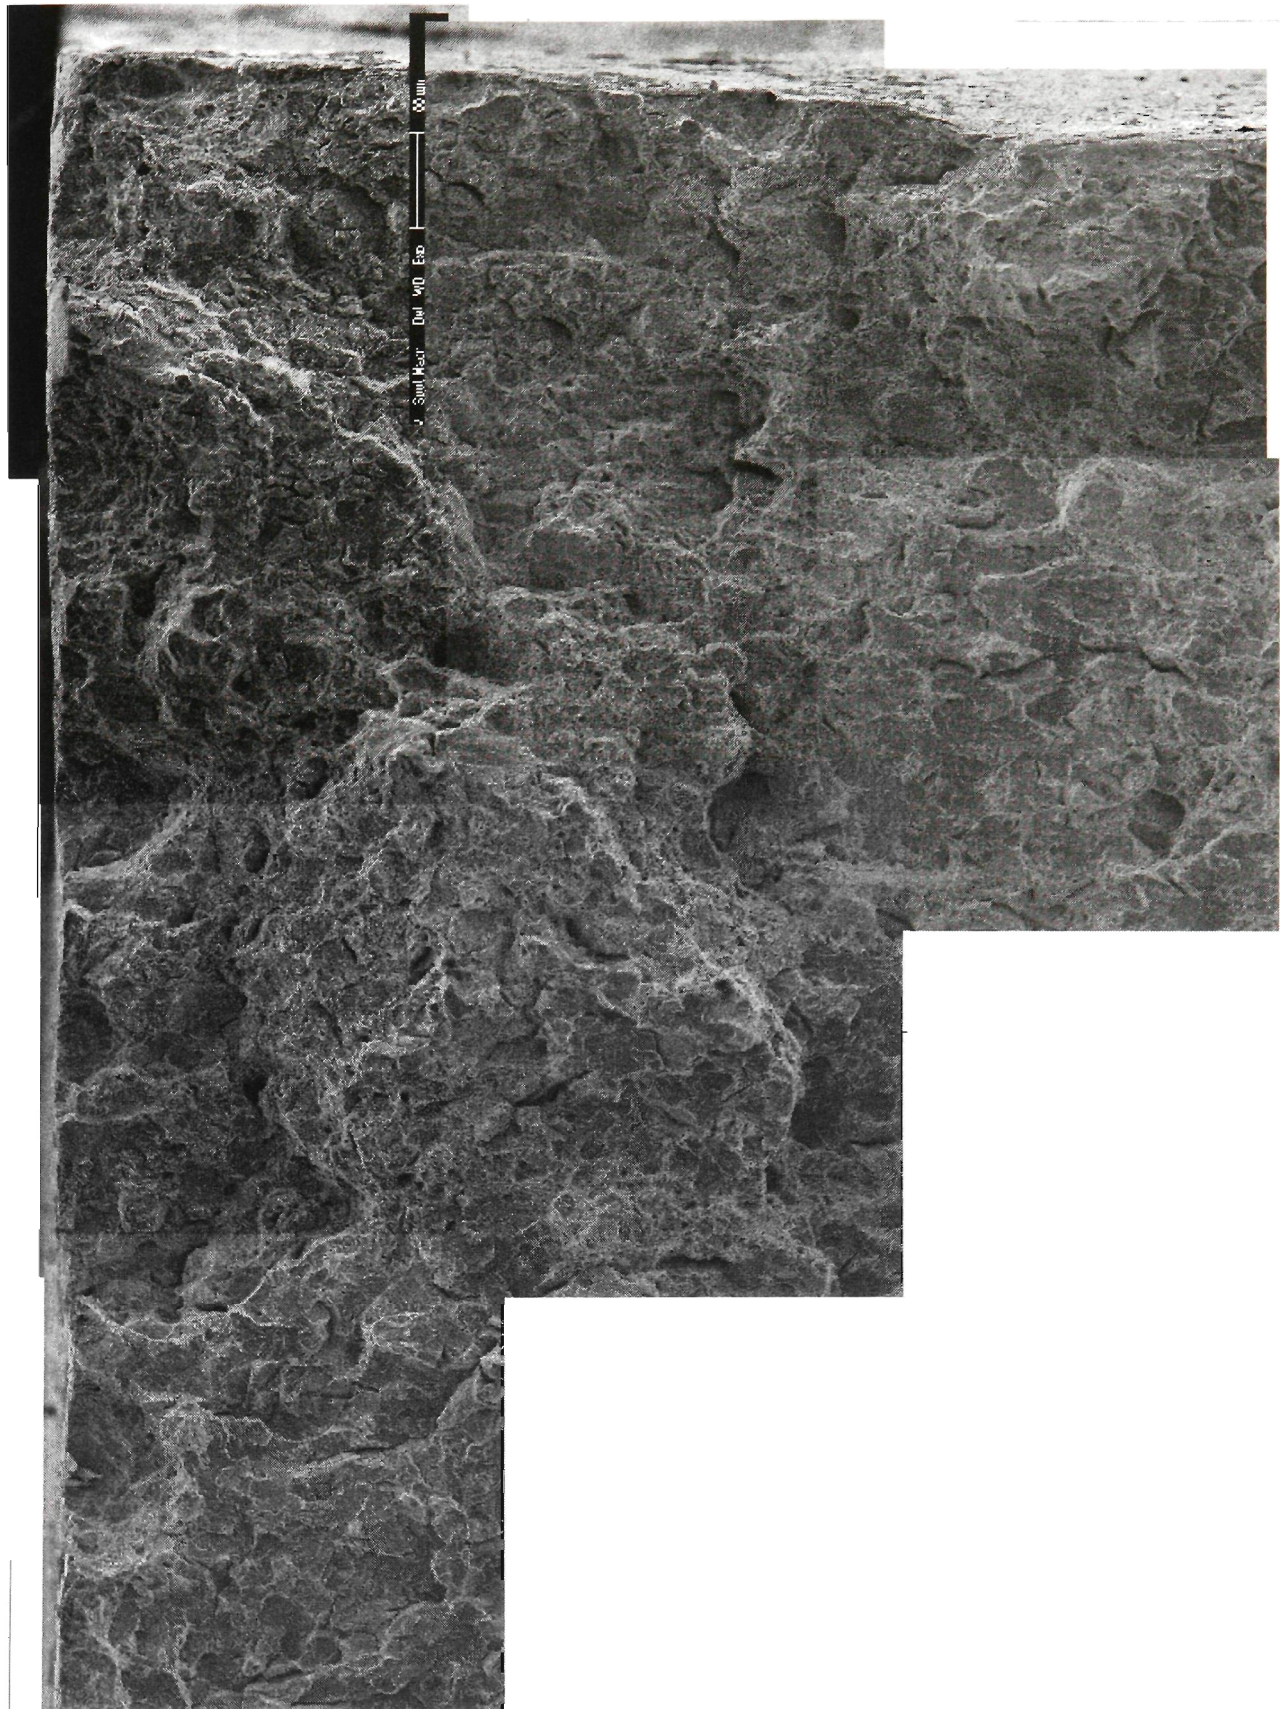
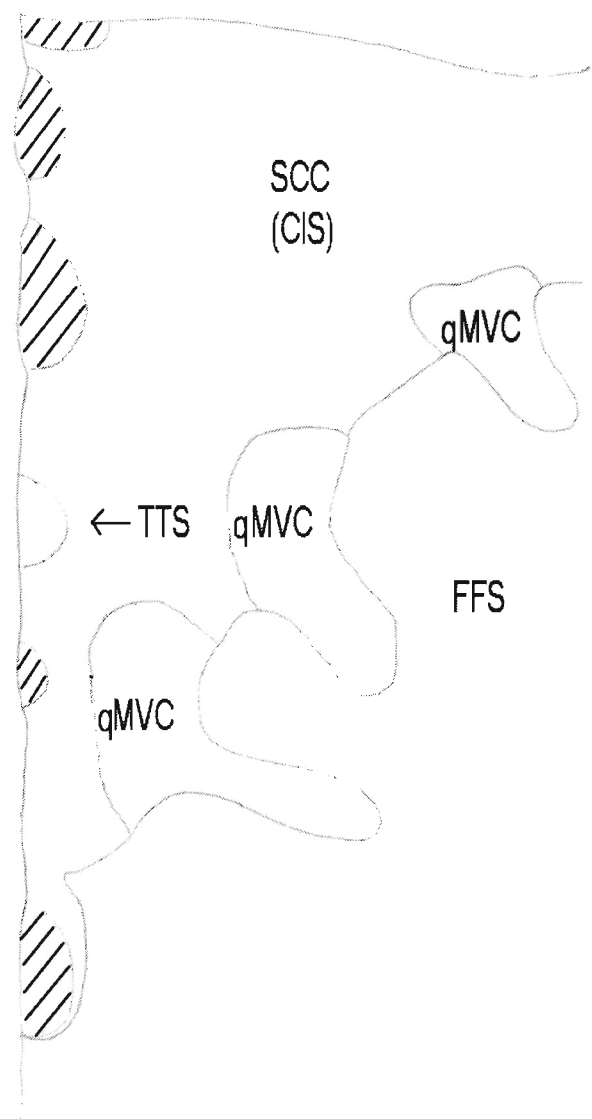
Figure 6.34(b) provides a map of Figure 6.34(a) identifying the regions as FFS, quasi Micro Void Coalescence (qMVC) and SCC. qMVC surfaces were identified by the amount of small pits and almost ductile fracture appearance. qMVC tended to appear away from the sample surface where hydrogen had not had as much time to diffuse throughout the material. It has been suggested that this qMVC region would fail as a TTS if enough hydrogen diffused into the area [53]. This suggestion was supported by the fact that qMVC regions appeared at the fringes of the SCC regions, penetrating into the FFS region in finger like protuberances. This in turn suggests that the SCC crack slowly advances into the material, with hydrogen slowly diffusing ahead of the crack tip. When the crack reached a critical size, the crack then propagated throughout the material in a fast brittle manner. The region immediately in front of the crack tip had received an amount of hydrogen that was not enough to allow the SCC to grow into that region, but enough to weaken the material to allow it to fail in a quasi ductile manner as it failed in a fast manner.

Within the SCC region there were three different and distinct fracture morphologies: Tearing Topography Surface (TTS), Corrugated Irregular Slopes (CIS), and Micro Void Coalescence (MVC). These are illustrated in Figures 6.53-6.55. Figure 6.34(a) provides an overview of the SCC region of a LIST fracture surface, with the schematic of Figure 6.34(b) identifying the various fracture micro-mechanisms.

(a) SCC region from Figure 6.33.

(b) Fracture regions in Figure 6.34(a). Shadowed regions are initiation pits.

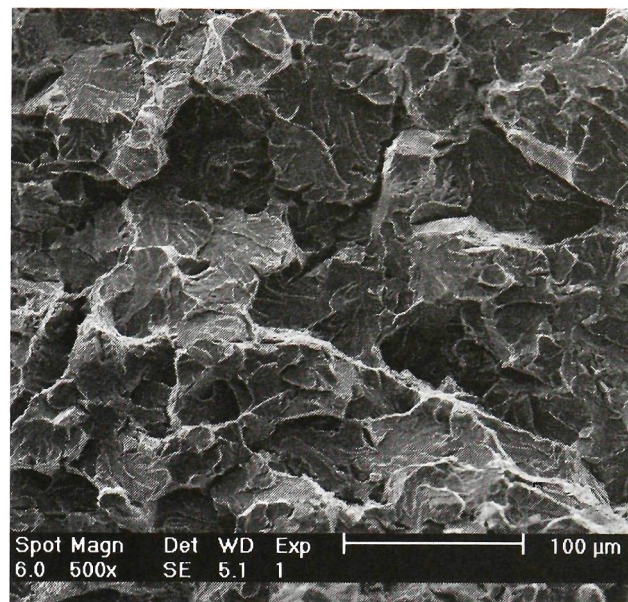
FIGURE 6.35: FFS in LIST sample at x500 magnification.

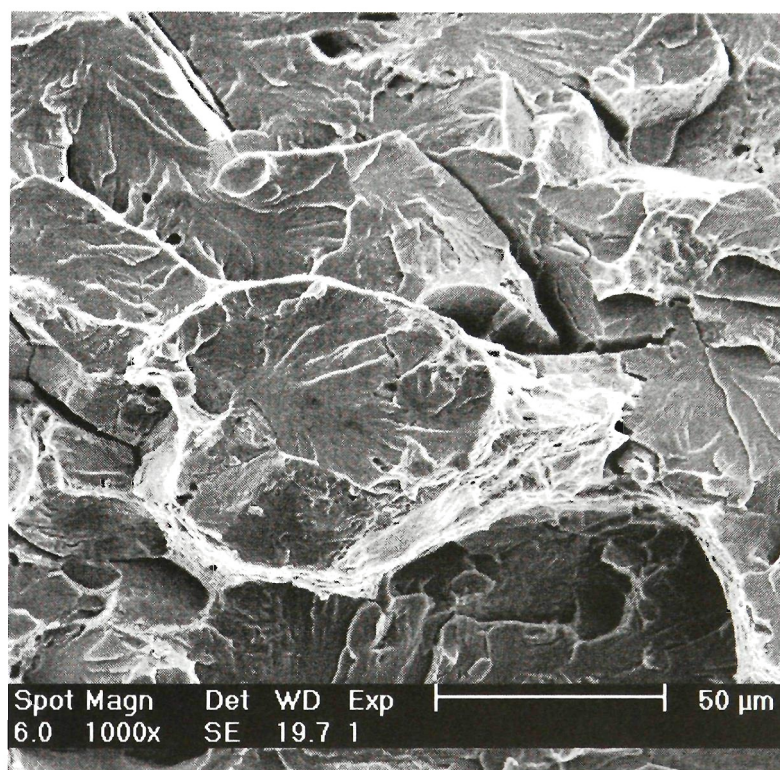
FIGURE 6.36: FFS in LIST sample at x1000 magnification.

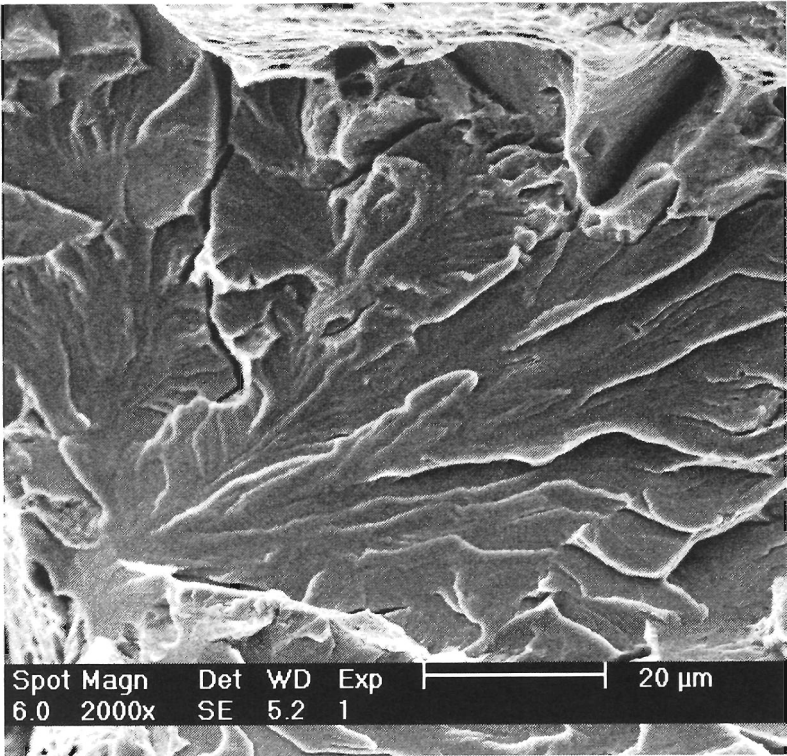
FIGURE 6.37: FFS in LIST sample at x2000 magnification.

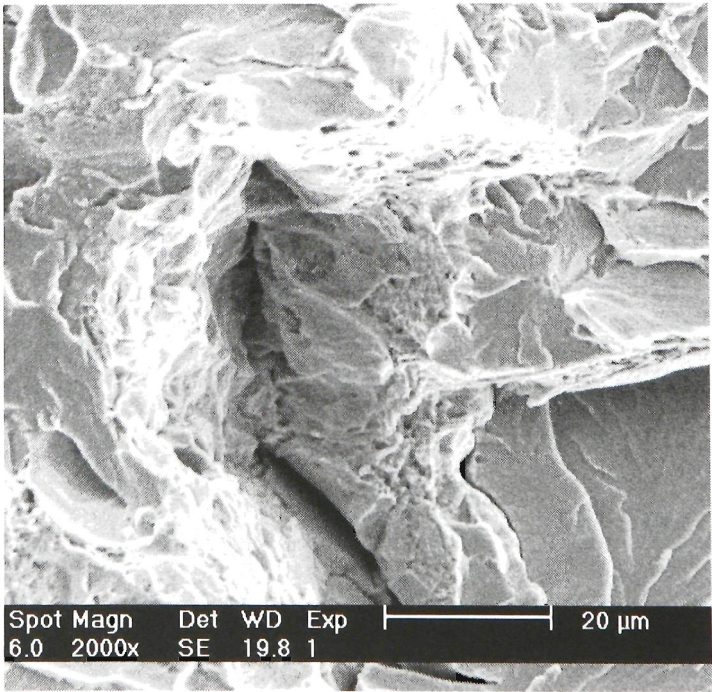
There were chasms between maple leaves in the LIST samples. Figure 6.38 depicts such a chasm, immediately surrounded by ductile tearing topography, with maple leaf features framing the chasm.

Chasms sometimes occurred between the maple leaves. This separation was attributed to the material ahead of the fast crack tip yielding plastically, pulling open the chasm by a small amount before the brittle crack reached around this plastic region and severed the plastic yielding tendril. This was supported by the dimpled rupture region in Figure 6.38, where just below the chasm there was a dimpled rupture region bounded by the flat featureless surface of the fast fracture region.

FIGURE 6.38: Chasm surrounded by ductile tearing topography amongst FFS maple leaves.

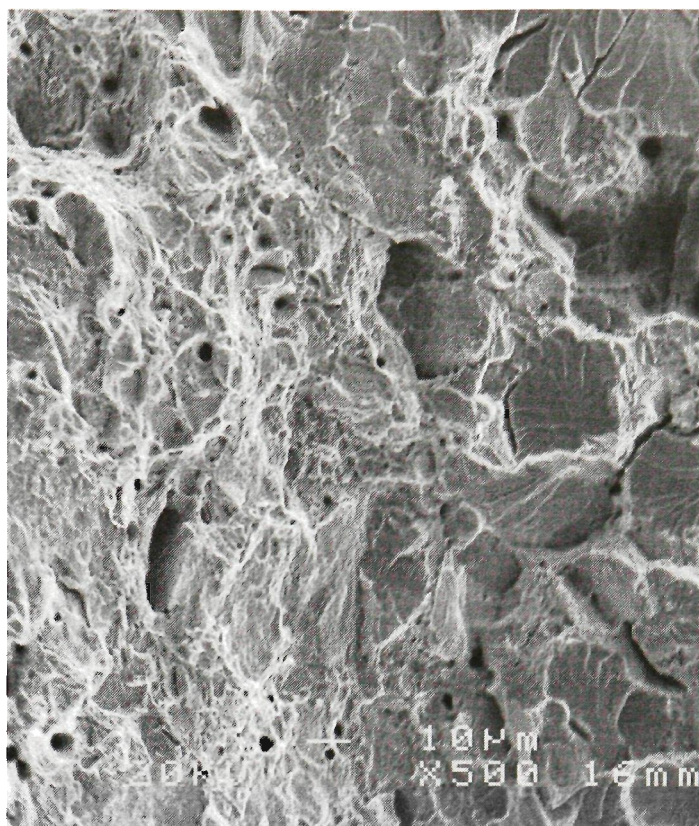
FIGURE 6.39: SCC to FFS transition from sample LIST07.

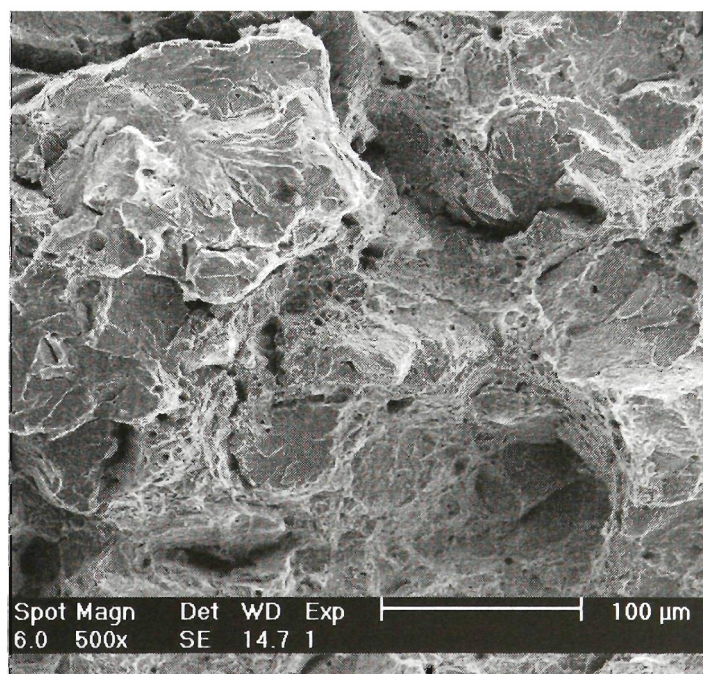
FIGURE 6.40: SCC to FFS transition from sample LIST40.

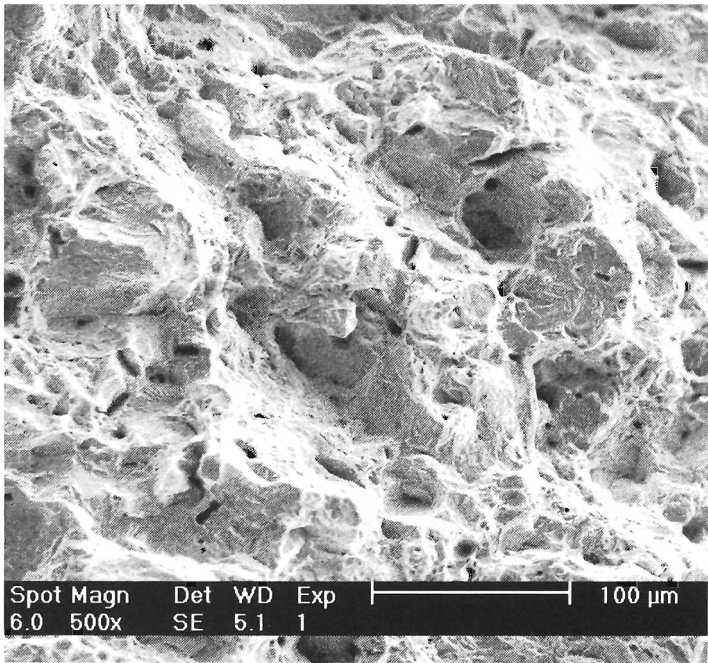
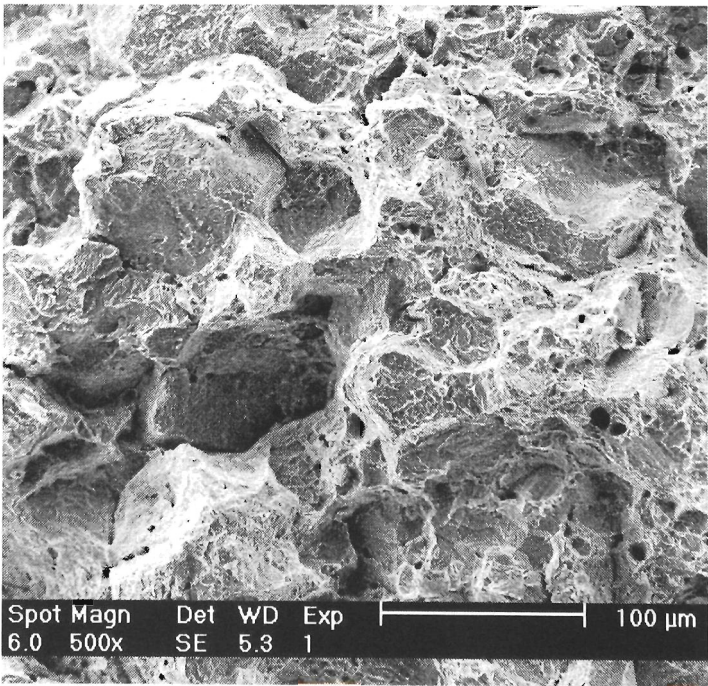
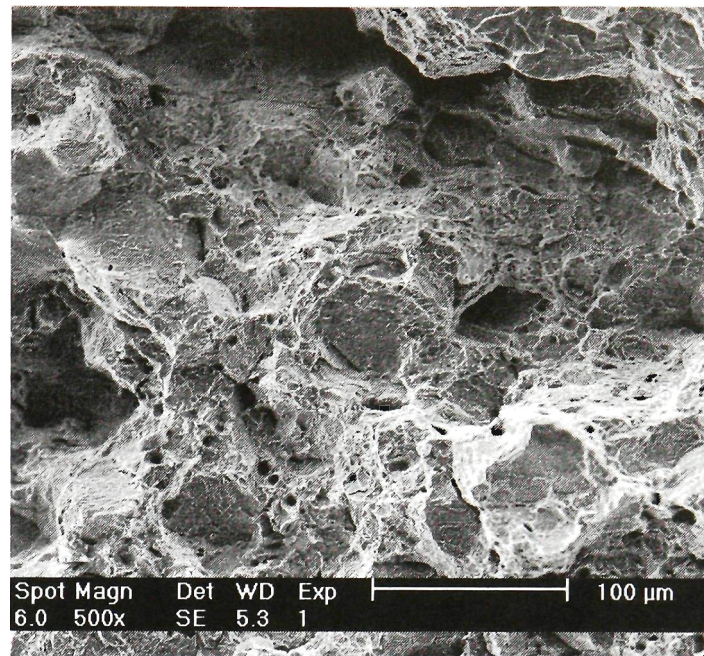
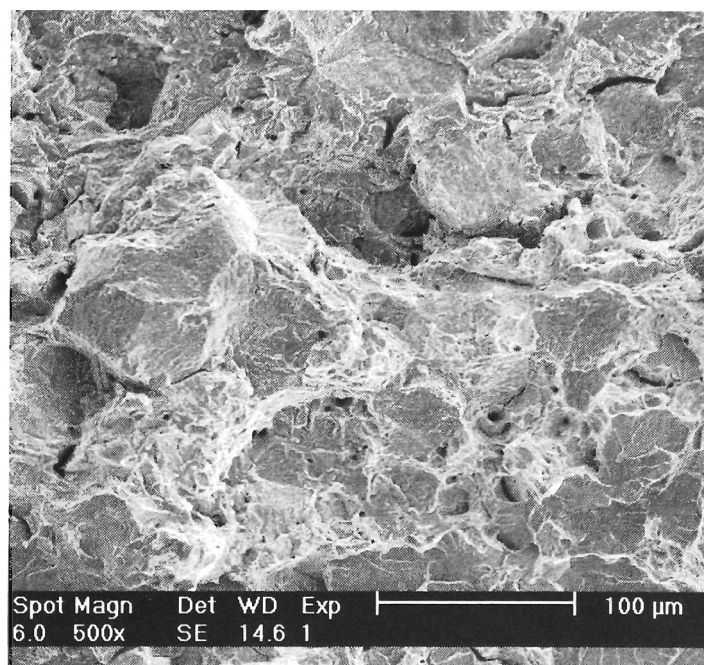
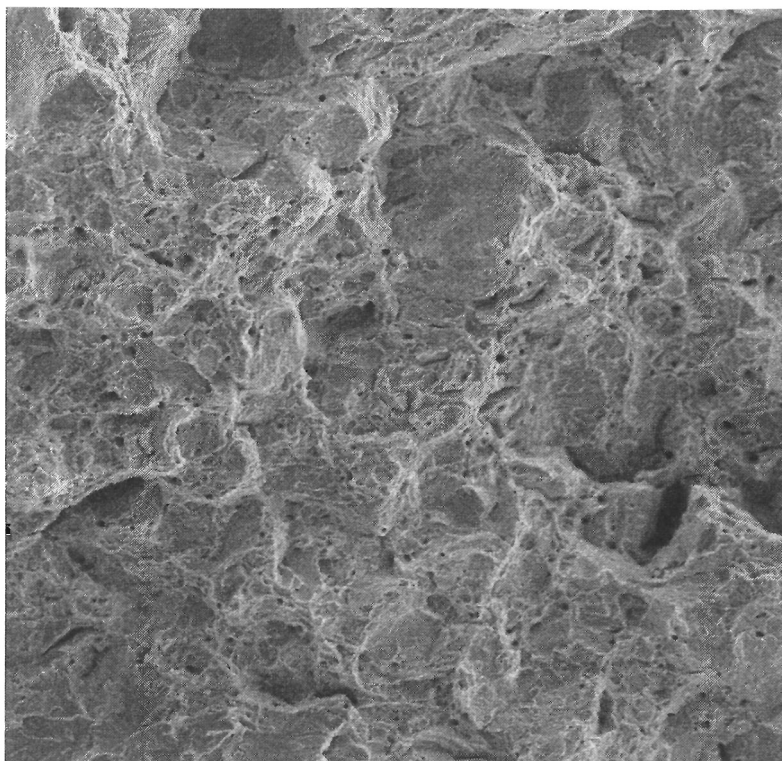
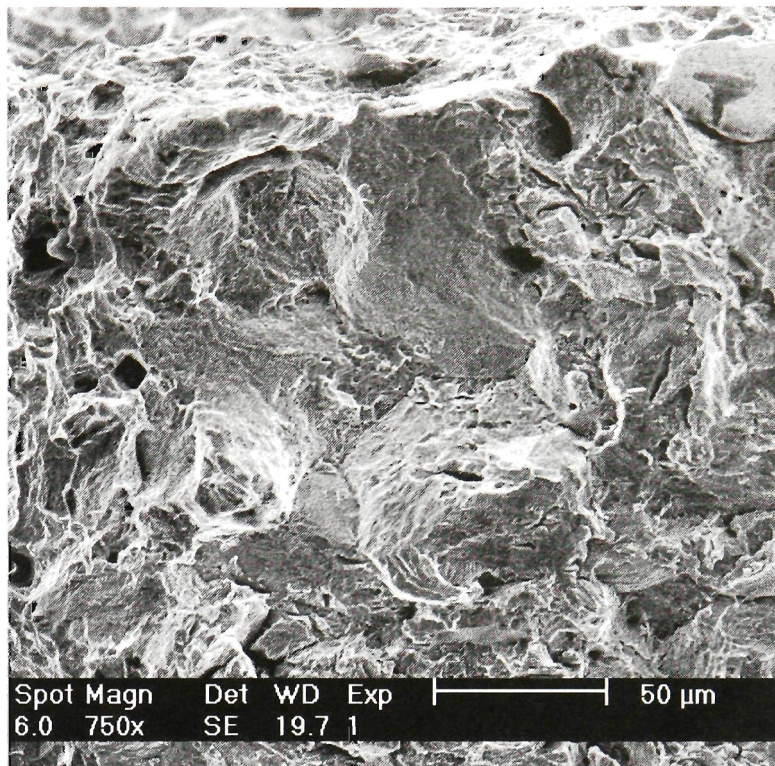
Figures 6.41, 6.42, 6.43, 6.44, 6.45 and 6.46 show typical fracture surfaces within the SCC region in LIST samples. These Figures show the CIS SCC morphology, although flat areas perpendicular to the field of vision were not common, particularly in Figure 6.41.

FIGURE 6.41: Typical CIS SCC fracture surface (LIST24). Several slopes with few flat areas.

FIGURE 6.42: Typical CIS SCC fracture surface (LIST38).

FIGURE 6.43: Typical CIS SCC fracture surface (LIST38).

FIGURE 6.44: Typical CIS SCC fracture surface (LIST39).

FIGURE 6.45: Typical CIS SCC fracture surface (LIST41).

FIGURE 6.46: Typical CIS SCC fracture surface (LIST38).
